Manhole Inspection Summary

Manhole # S19GG2020MH

Insp Date: **7/15/08 10:48 AM**

Location Address: **5901 FALLS RD** Cross Street: **BELLEMORE RD**

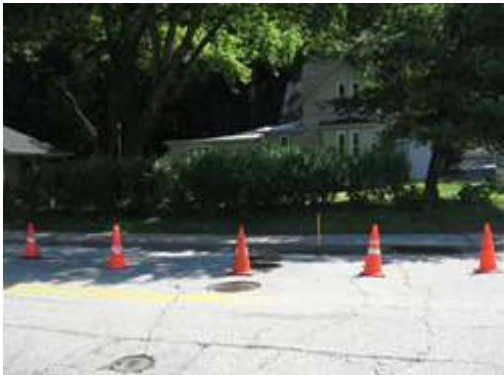
Location View

Falls Rd looking towards address 5901

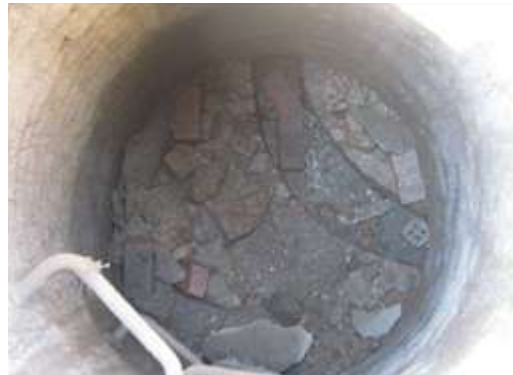
Top View

Bench ☒ Exists Material: **Brick** ☐ Parged ☒ **Debris** (not Condition related)
Condition: ☒ Sound ☐ Cracked ☐ Root Intrusion ☐ Deteriorated ☐ Leaks ☐ Debris

Channel Material: **Brick** ☐ Parged ☐ Debris (not Condition related)
Channel Exposure: **Fully Open** Junc Dist: **0** nearest .5 ft. Azimuth:
Condition: ☐ Sound ☐ Cracked ☐ Root Intrusion ☐ Deteriorated ☐ Leaks ☒ **Debris**

Bench and Channel debris.

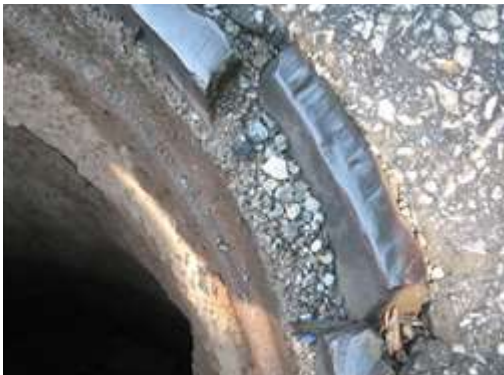
Defect

Comments **MH looks to be abandoned. The Frame is broken**

Frame Offset: **0** (in.) Condition: ☐ Sound ☒ **Cracked** ☒ **Leaks**

Broken frame.

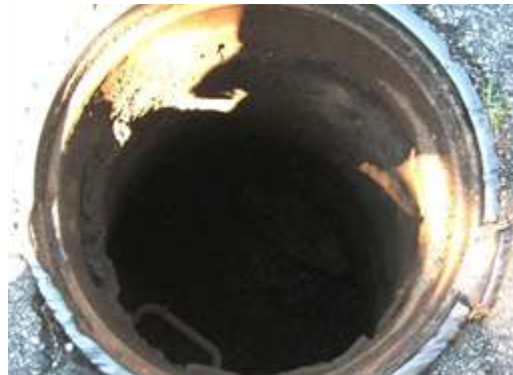
Defect

Chimney / Frame Adjustment ☒ Exists Material: **Brick** ☐ Parged Height: **5** (in.)
Condition: ☐ Sound ☐ Cracked ☐ Root Intrusion ☐ Loose Brick ☒ **Deteriorated**
Infiltration: ☐ None ☒ **Joint** ☐ Cracks ☐ Mortar ☐ Roots ☒ **Wall**

Barrel Material: **Brick** ☐ Parged
Shape: **Circular** Diameter: **42** (in.) Length: (in.)
Condition: ☒ Sound ☐ Cracked ☐ Root Intrusion ☐ Loose Brick ☐ Deteriorated
Infiltration: ☐ None ☐ Joint ☐ Cracks ☐ Mortar ☐ Roots ☒ **Wall**

Broken and worn frame. Frame leaks. Adjustment deterioration and infiltration. Barrel infiltration.

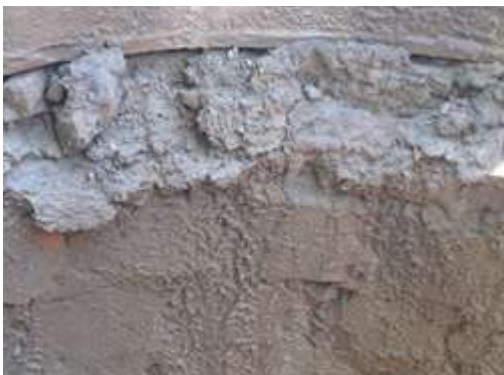
Defect

Frame leaks. Adjustment deterioration and infiltration.

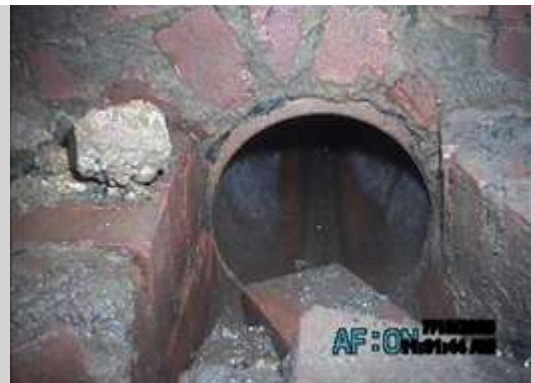
Pipe Out @ 12 O'Clock

Deposits: ☐ None ☐ **Mud** ☐ Sludge ☒ **Debris** ☐ Grease

Silt Depth: **0** (in.) Deposits Extent: **Light**

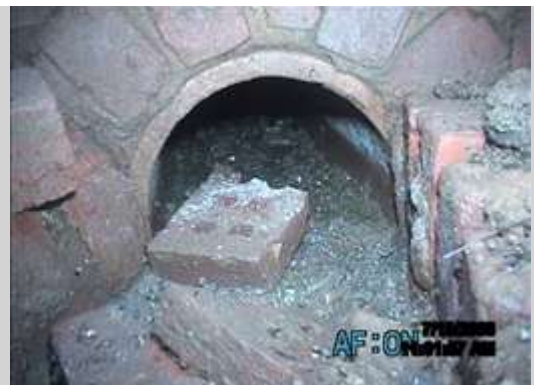
Pipe In @ 4 O'Clock

Deposits: ☐ None ☒ **Mud** ☐ Sludge ☒ **Debris** ☐ Grease

Silt Depth: **2** (in.) Deposits Extent: **Medium**
